Technical Report 217

FY 77 SUBSEA SLOW-SCAN ACOUSTIC TELEVISION (SUBSAT) TESTS

A Gordon

March 1978

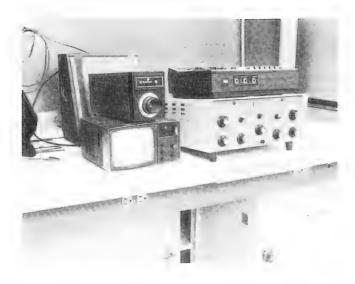
Figure 3. SUBSAT hardware.

Figure 3 shows the equipment used, except for the UQC. Note the scale provided by the ruler below the Robot 400.
